Sunnyview Pre-Construction Monitoring Report

Prepared for:
The Harford County
Department of Public
Works

December 2006
Revised April 2007

Prepared by:
KCI Technologies Inc.
10 North Park Drive
Hunt Valley, MD
21030

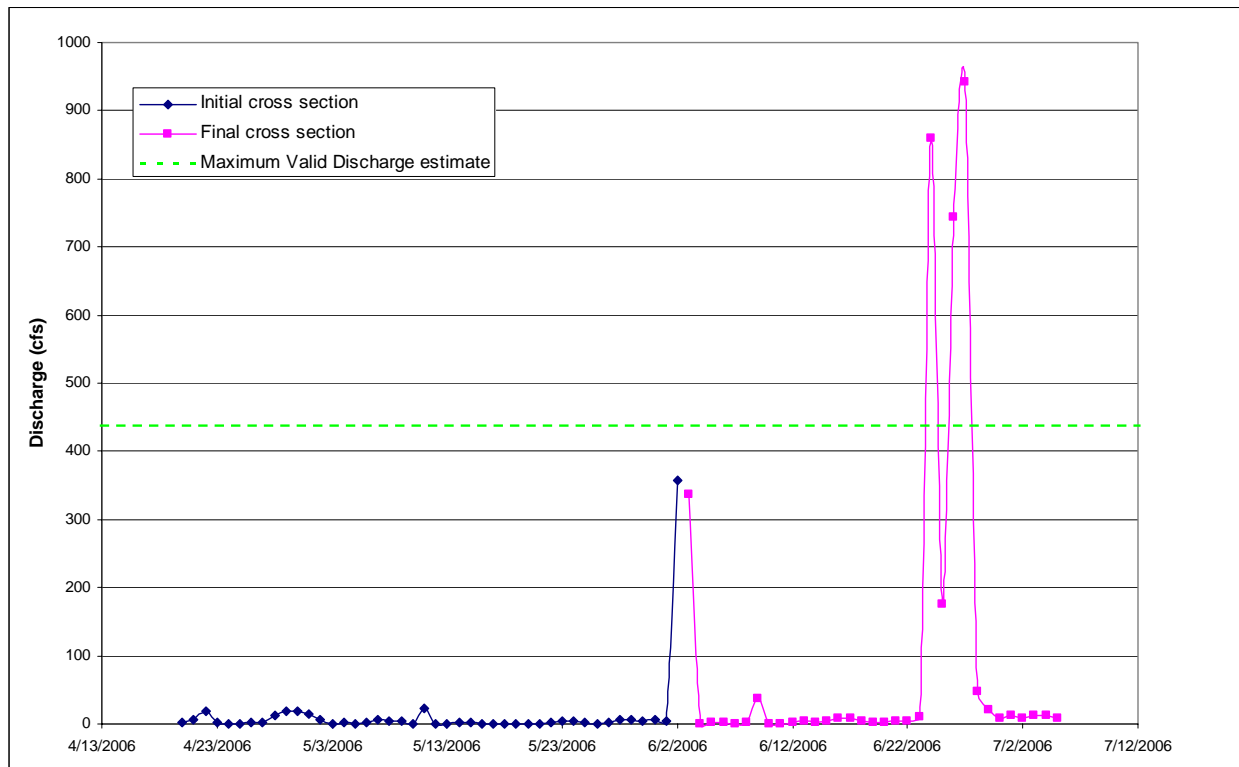
Figure 3- Daily Maximum Estimated Discharge at Sunnyview for Year 1 Monitoring

The daily maximum discharge estimated from the data loggers is shown in Figure 3. During the course of the sampling events a portion of the gauged cross section was buried while another was scoured. This change was verified with an additional survey of the cross section. It is estimated that the change in the cross section did not occur until the June 3, 2006 storm. The discharge for storms prior to June 3rd were estimated using the initial cross sectional area while storms occurring after this date us the final cross sectional area. The rating curve and cross sectional data at the gauge can be found in Appendix D.

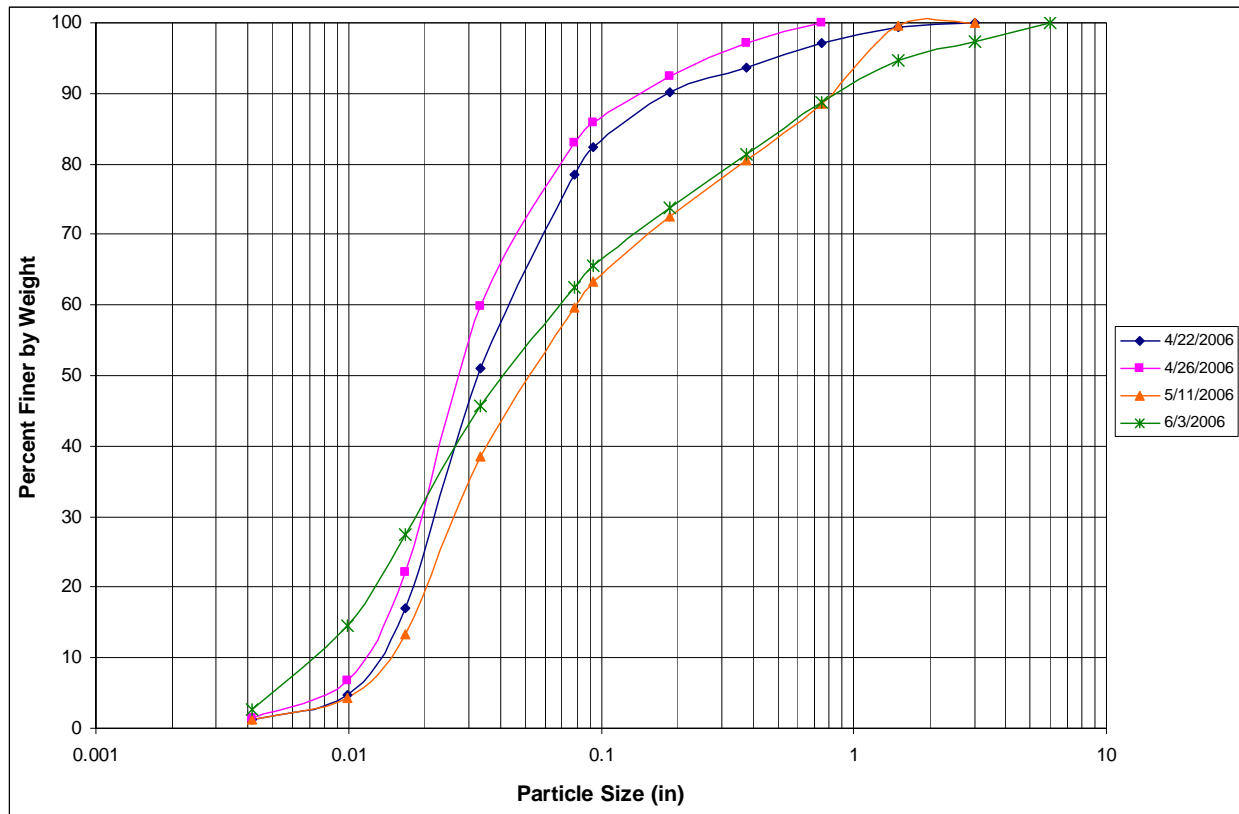
Figure 4- Particle Size Distribution from Sediment Traps at Sunnyview for Year 1 Monitoring

Sediment samples were analyzed four times from April- June 2006 for this 2005 report. The particle size distribution for the collected samples is shown in Figure 4 below. The full particle size report from each storm is included in Appendix D. Results for the estimated discharge and largest particle collected per sampling storm event are shown in Table 3.6. Average daily flow at the site was below 1.0 cfs. Storm events associated with discharge greater than 2.72 cfs showed a dramatic increase in the largest particle size collected. This may correspond to the threshold between suspended load and bed load movement.

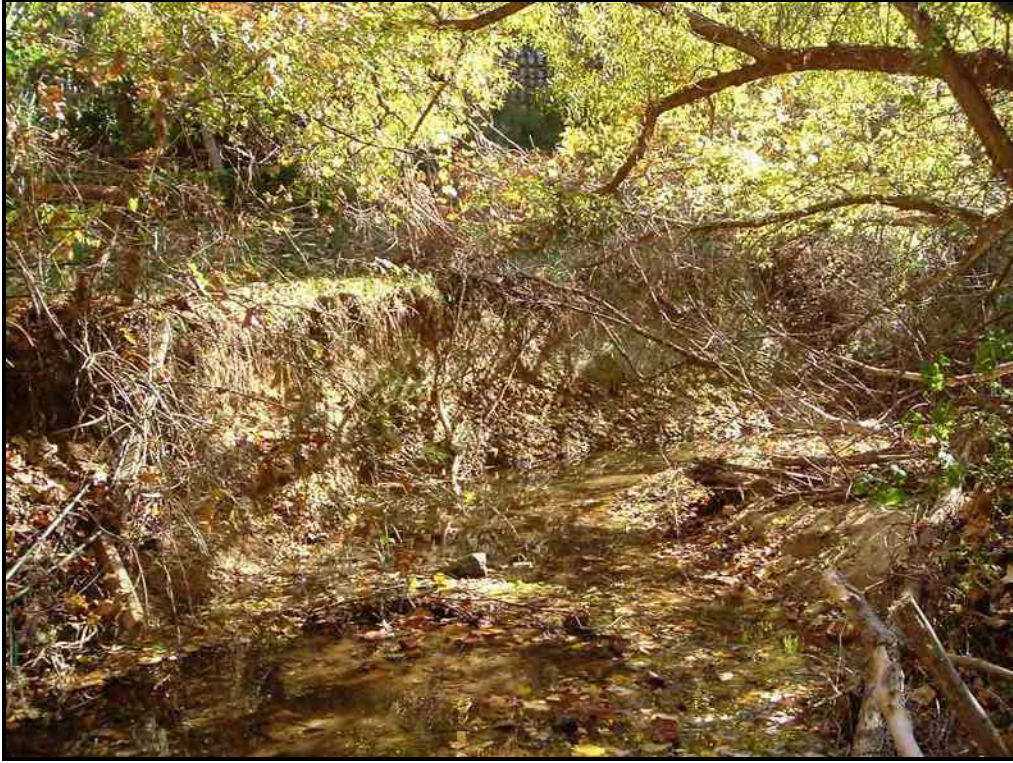
Photo 9 Facing down stream at meander bank at station 4+38

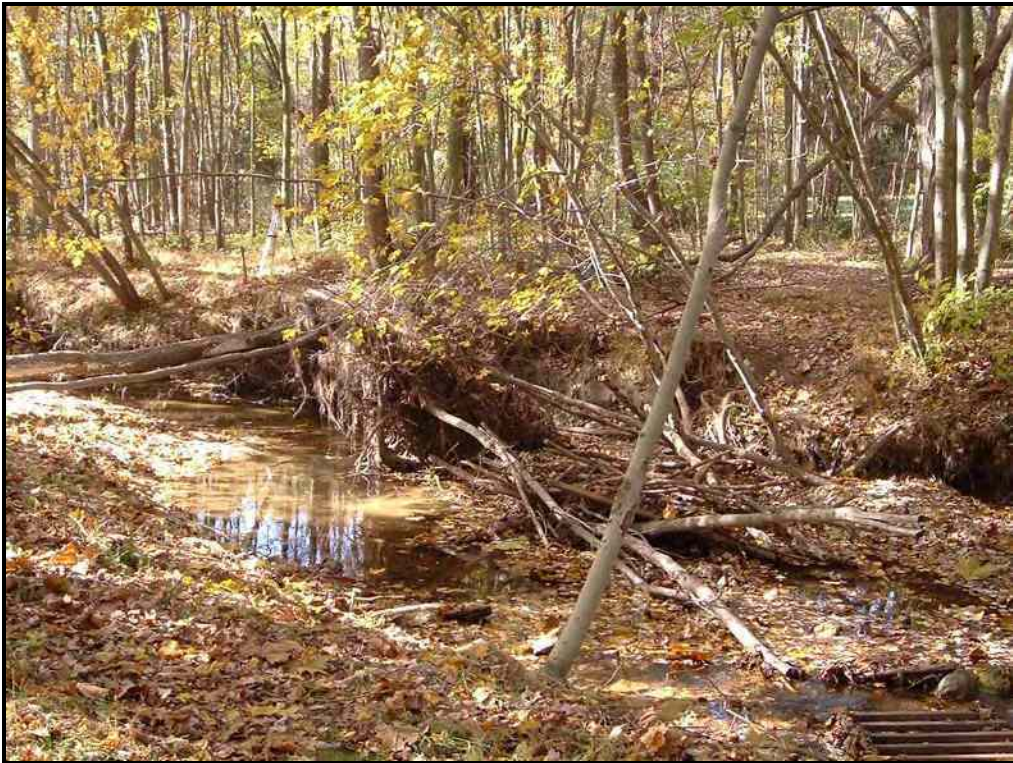
Photo 10 Facing up stream at meander bank at station 4+38
